**NL INDUSTRIES/TARACORP SUPERFUND SITE GROUP**  
**Leed Environmental, Inc.**  
**Van Reed Office Plaza**  
**2209 Quarry Drive, Suite C-35**  
**Reading, PA 19609**  
**Telephone: (610) 670-7310**  
**Facsimile: (610) 670-7311**

**Re: NL Industries/Taracorp Superfund Site; Granite City, Illinois**  
**First 2017 Semi-Annual Operation and Maintenance Inspection (May 2017)**

**NL Industries/Taracorp Superfund Site  
Inspection Log - Operation and Maintenance**

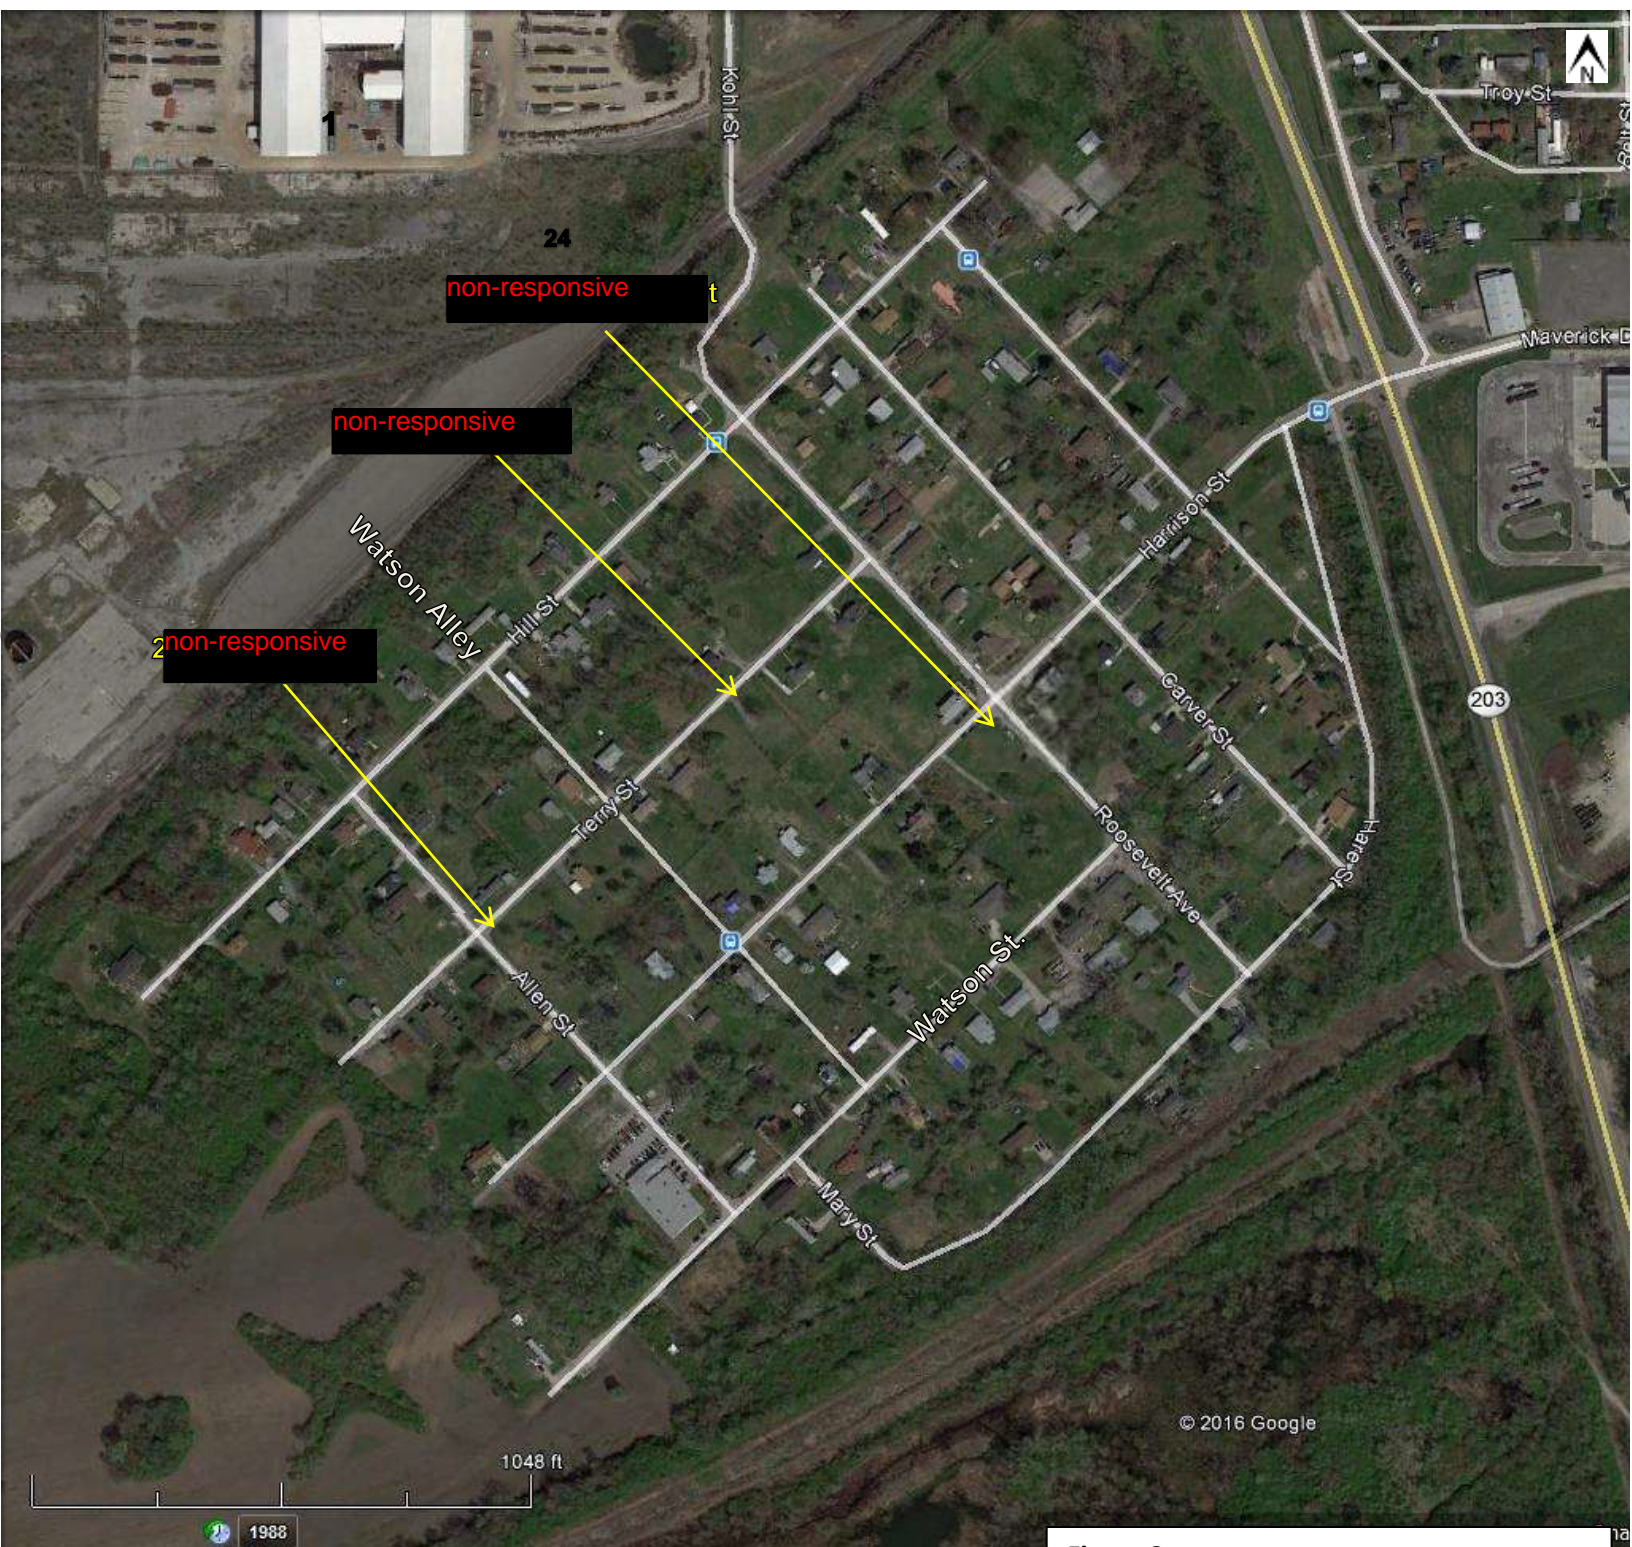
**Figure 3**  
**Eagle Park Acres - Remote Fill Properties**  
(non-responsive  
non-responsive )

- Three remote fill properties (200 Harrison Street, 206 Terry Street, and 200 Allen Street) in Eagle Park Acres (Figure 3) that were previously remediated by EPA (and where lead-impacted soil and/or battery case chips may remain in place at a depth of three feet below the ground surface) were observed during the inspection. As shown on the photographs in Attachment 3, the properties are vacant and no evidence of subsurface soil disturbance was observed.

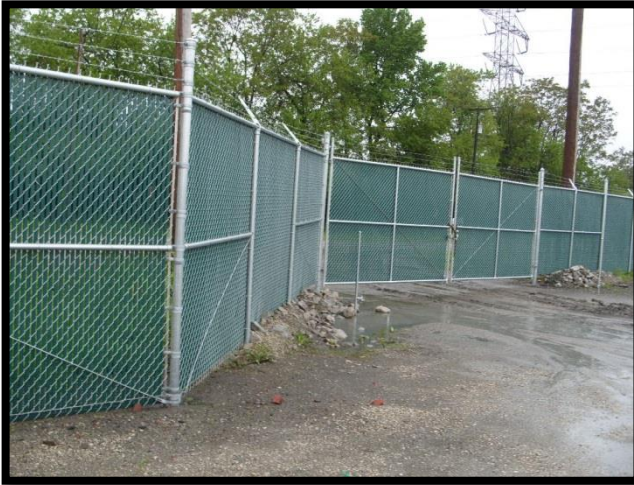
Photograph 3: Slough Road, inside of fence along Bremen Street.

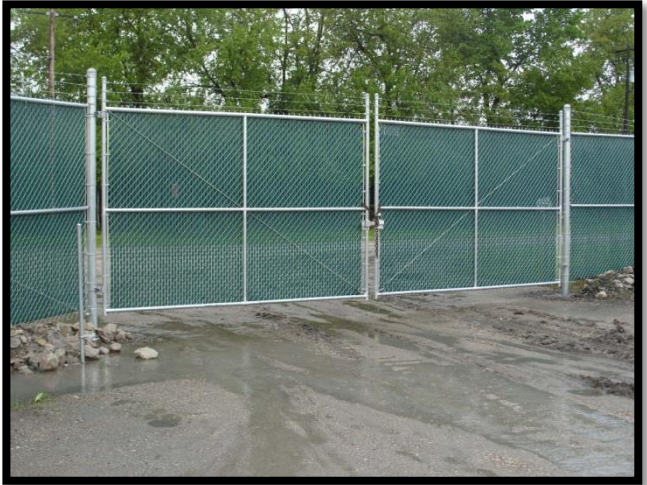
Photograph 4: Slough Road, inside of gate/fence along Bremen Street.

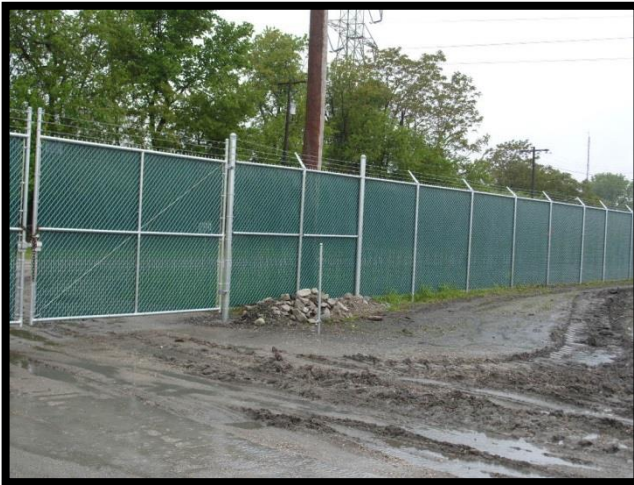
Photograph 5: Slough Road, inside of gate/fence along Bremen Street.

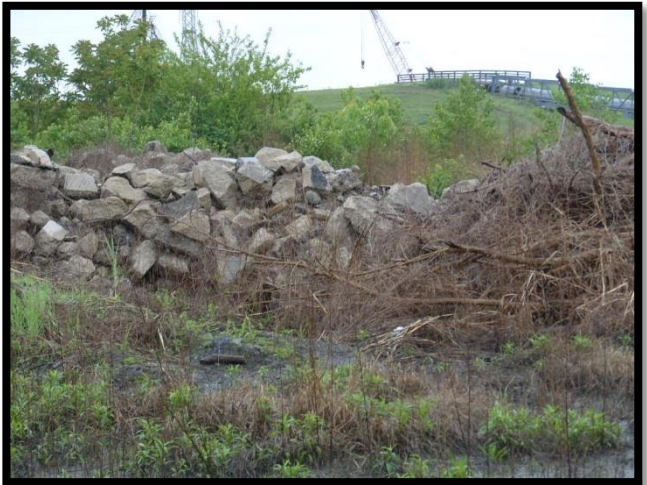
Photograph 6: Slough Road, concrete debris pile.

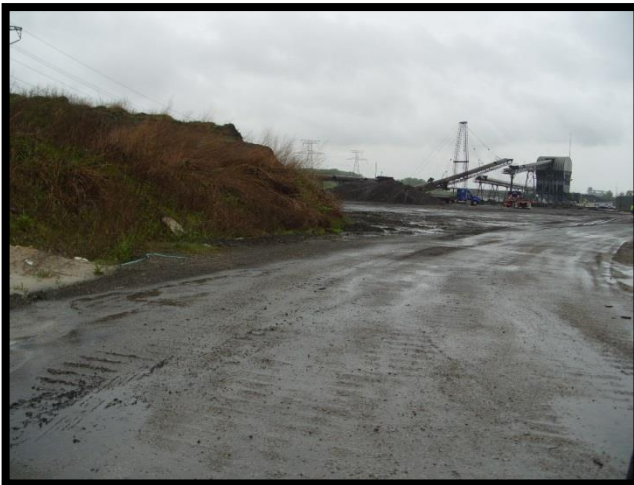
Photograph 9: Slough Road, roadway.

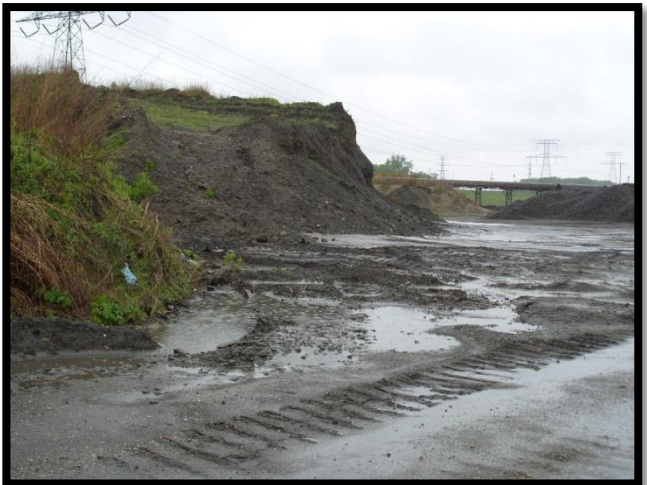
Photograph 10: Slough Road, roadway.

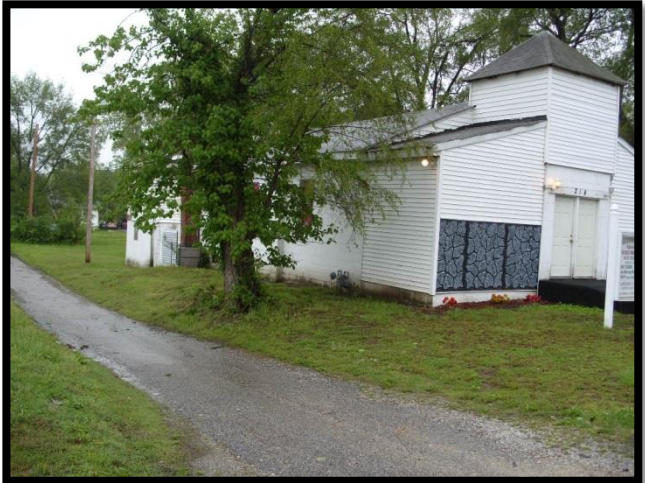
2. The paved portion of Watson Alley in Eagle Park Acres (as shown on Figure 2 and the photographs in Attachment 2) was inspected and noted to be in good condition.

Photograph 4: Watson Alley, paved area (view from Harrison Street).

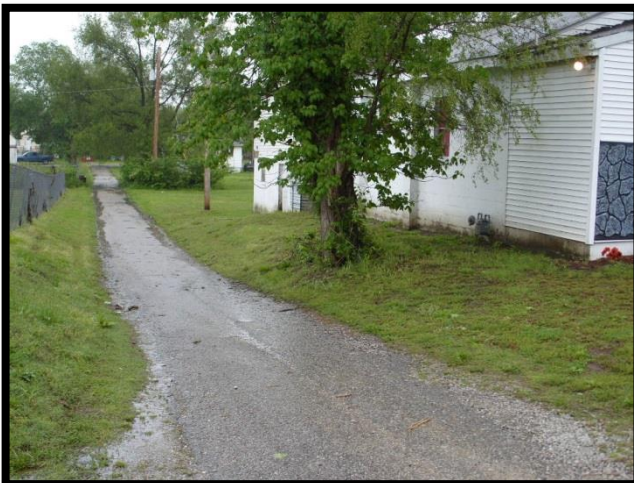
Photograph 5: Watson Alley, paved area (view from Harrison Street).

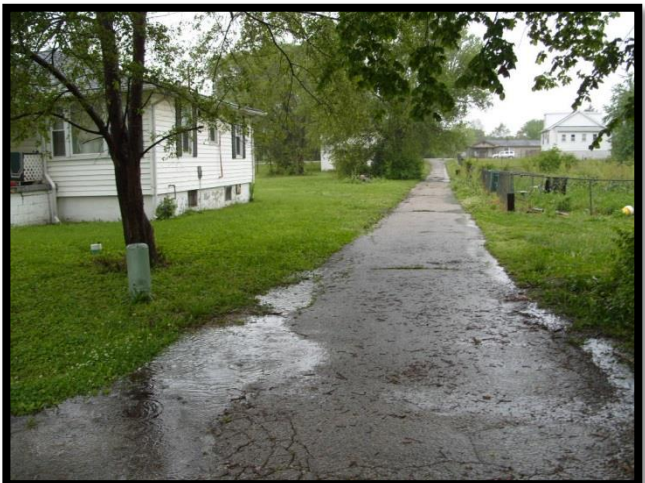
Photograph 6: Watson Alley, paved area (view from Watson Street).

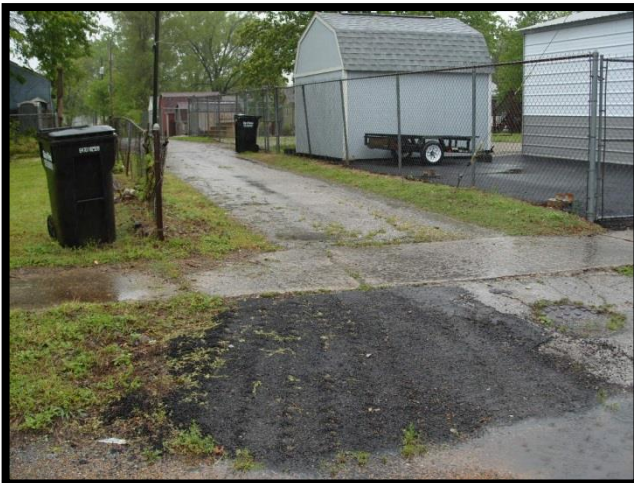
areas, with no battery case chips visible. The Venice alleys are shown on Figure 1 and are identified on the photographs in Attachment 4. Previous inspections have confirmed that the local municipality is continuing to repair and repave alleys, as necessary (Attachment 4, photograph 9).

Site Structure	Inspected (yes/no)	Inspection Observations	Maintenance Work Performed or Required
<b>Concrete Drainage Channel</b>			
Evidence of cracks or obstructions	Yes	No significant cracks or obstructions. Due to heavy rain at the time of the inspection, the concrete drainage channel was observed to be effective in conveying storm water runoff away from the Taracorp pile.	
Areas of erosion	Yes	No erosion observed.	
Comments			
<b>Asphalt Covers - Integrity</b>			
Evidence of broken asphalt or fissures	Yes	Some minor asphalt cracking and deterioration was observed in small areas along the sides of several paved alleys in Venice. Evidence of recent paving / patching of the alleys by Venice Township was observed along 6th Street (Attachment 4, photograph 9).	
Indicate areal extent and location	---		
Comments

Photograph 9: Alley between Jefferson Street and Washington Street (view southwest from 6<sup>th</sup> Street).

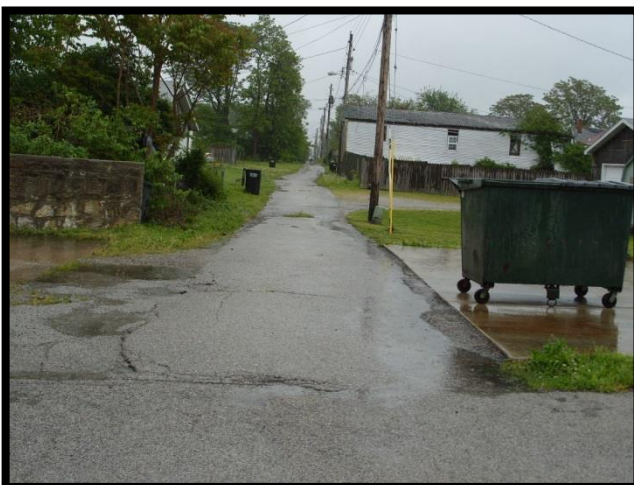
Photograph 11: Alley between Bissell Street and Market Street (view east from Baucum Street).

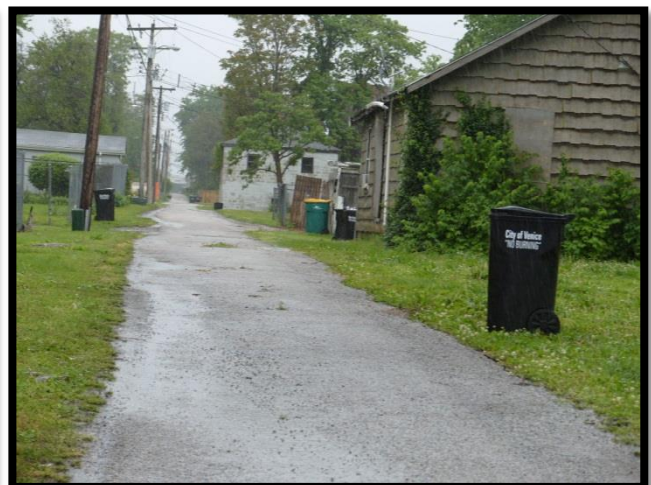
Photograph 12: Alley between Market Street and Logan Street (view east from Baucum Street).

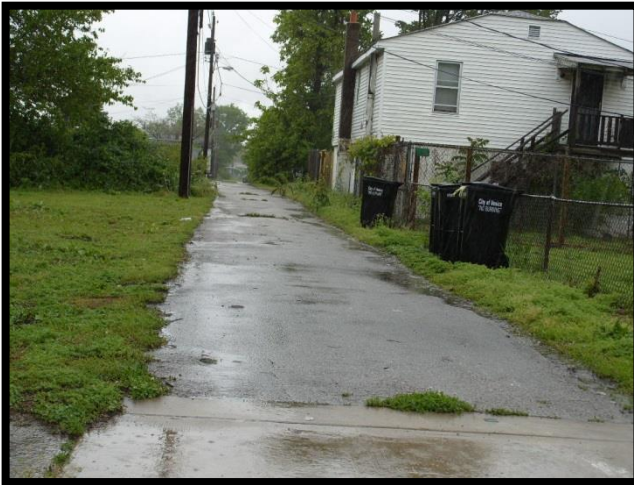
Photograph 13: Alley between Bissell Street and Market Street (view west from Meredocia Street).

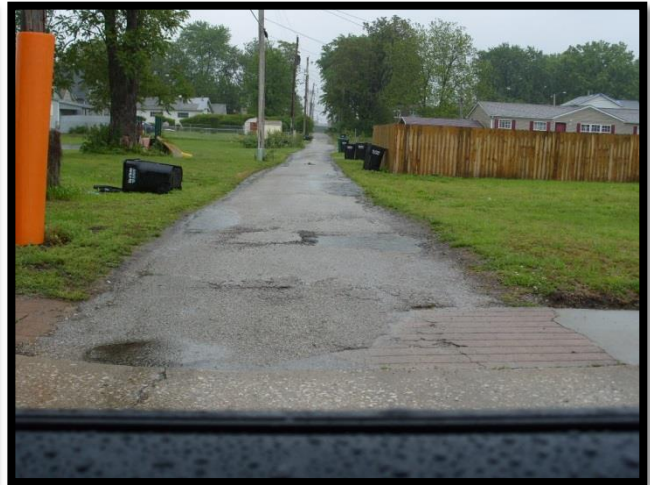
Photograph 14: Alley between Market Street and Logan Street (view east from Meredocia Street).

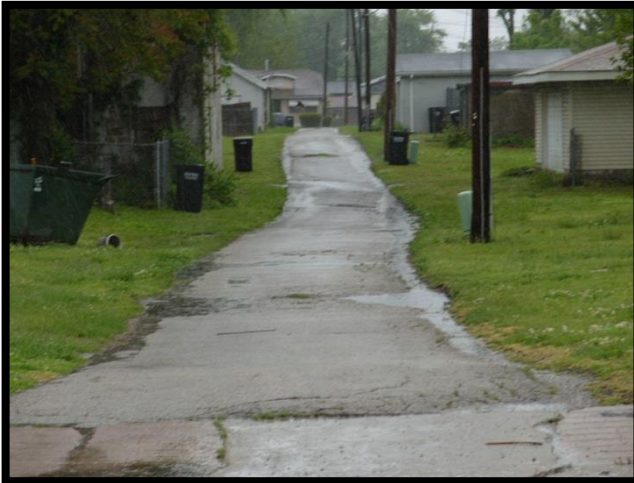
Photograph 15: Alley between Market Street and Logan Street (view west from Meredocia Street).

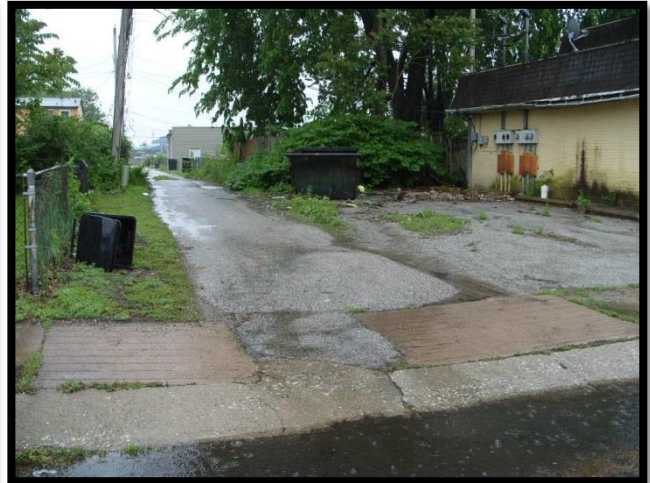
Photograph 16: Alley between Market Street and Logan Street (view east from Selb Street).

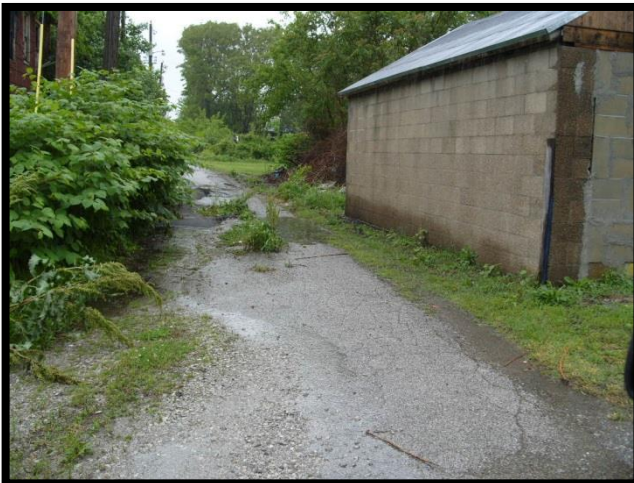
Photograph 17: Alley between Calhoun Street and Douglas Street (view west from Line Alley); several holes have been filled with asphalt since June 2012 inspection.

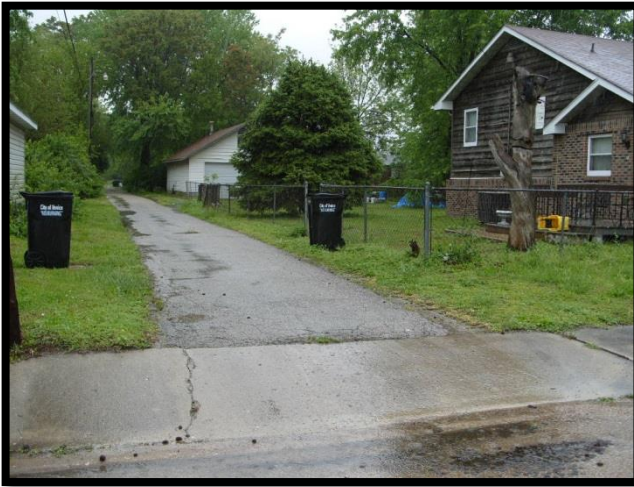
Photograph 19: Alley between Allen Street and Rogan Street (view north from Allen Street).

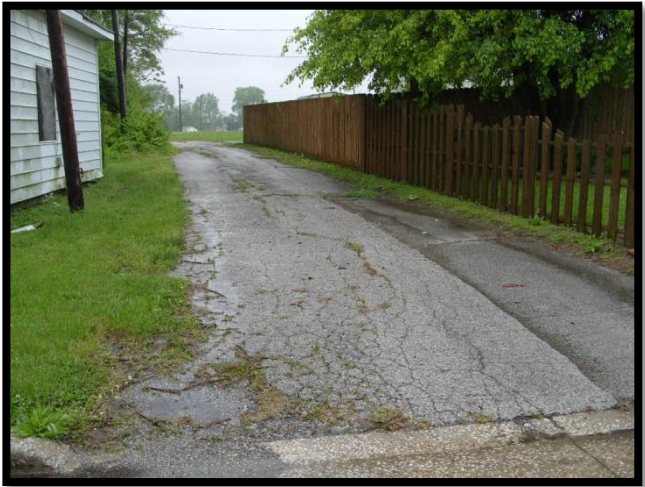
Photograph 20: Alley between Baucum Street and West 3<sup>rd</sup> Street (view south from Madison Street and College Street).

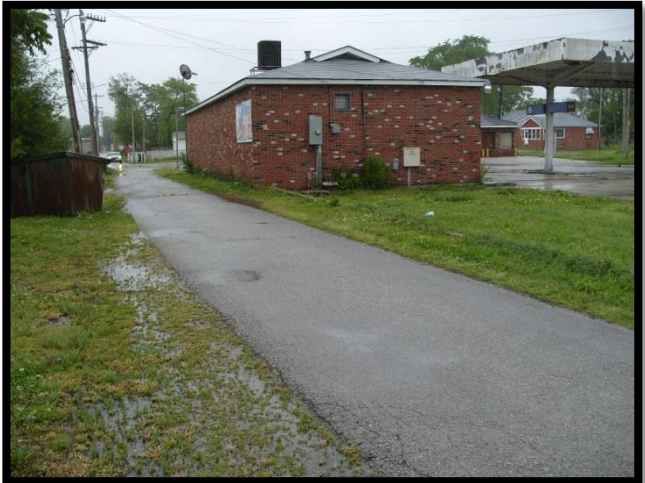
Photograph 22: Alley between 4<sup>th</sup> Street, Broadway, and Lincoln Avenue.

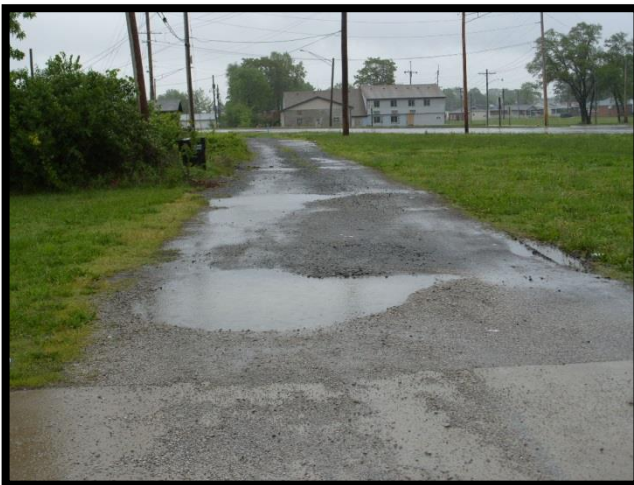
Photograph 23: Alley (gravel) between 3<sup>rd</sup> Street and 4<sup>th</sup> Street (view north from Abbott).

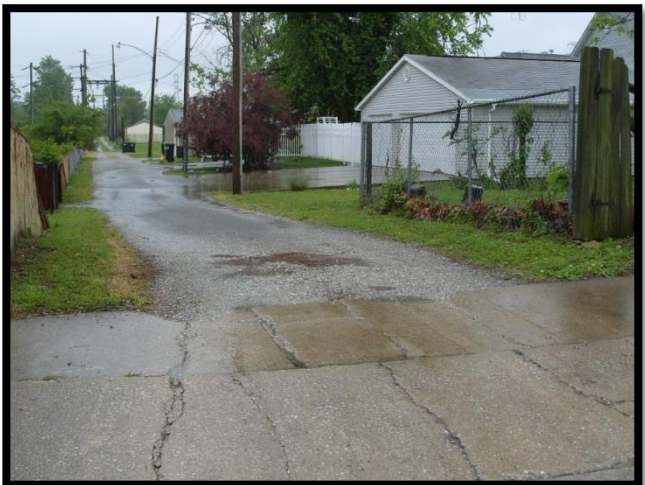
Photograph 24: Alley between 3<sup>rd</sup> Street and 4<sup>th</sup> Street (view south from Granville).

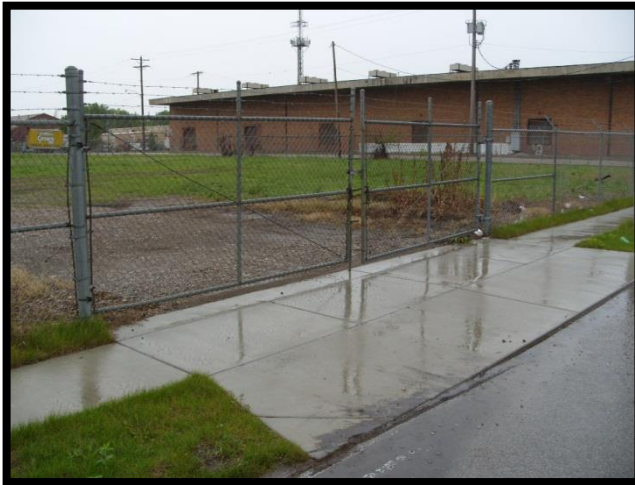
Photograph 1: Entrance to 1555 State Street property along State Street.

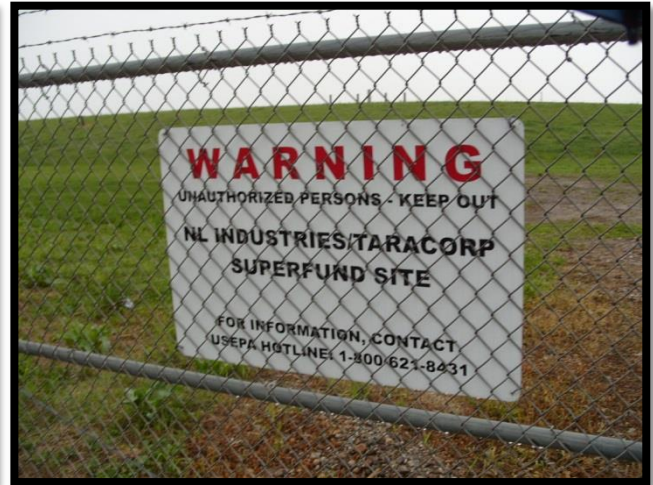
Photograph 2: Warning sign at front gate along State Street.

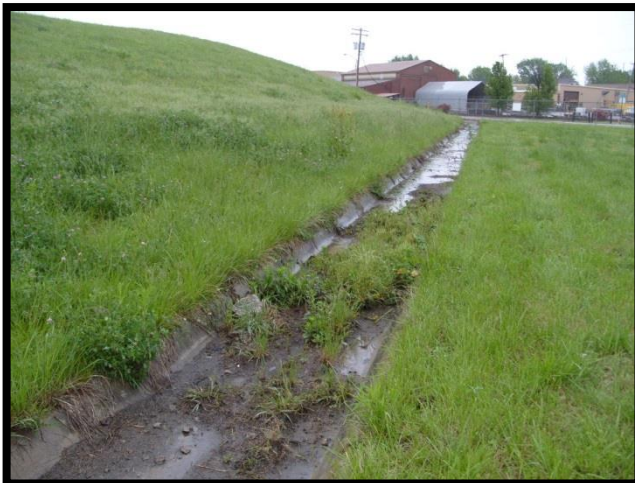
Photograph 3: Concrete drainage swale, east side of Taracorp pile (view north).

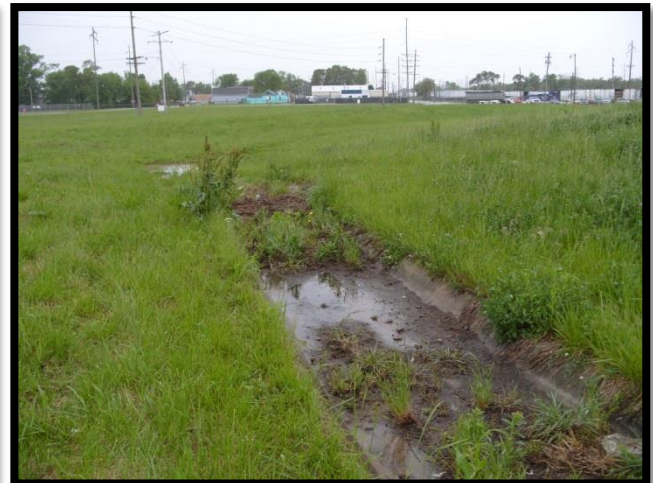
Photograph 4: End of concrete drainage swale, east side of Taracorp pile.

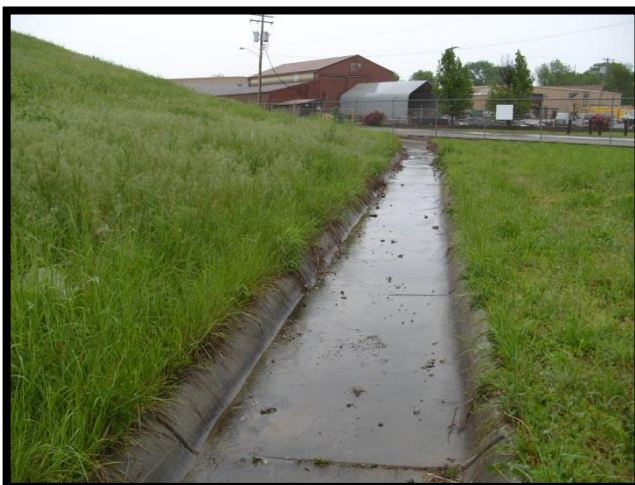
Photograph 5: Concrete drainage swale, east side of Taracorp pile (view north).

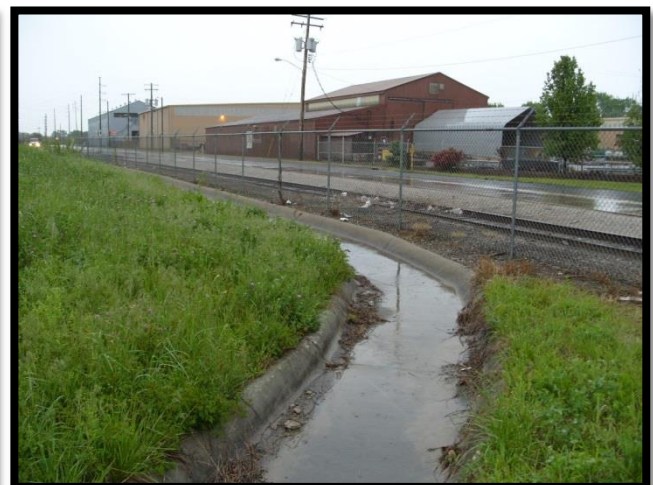
Photograph 6: Concrete drainage swale, east side of Taracorp pile (view north).

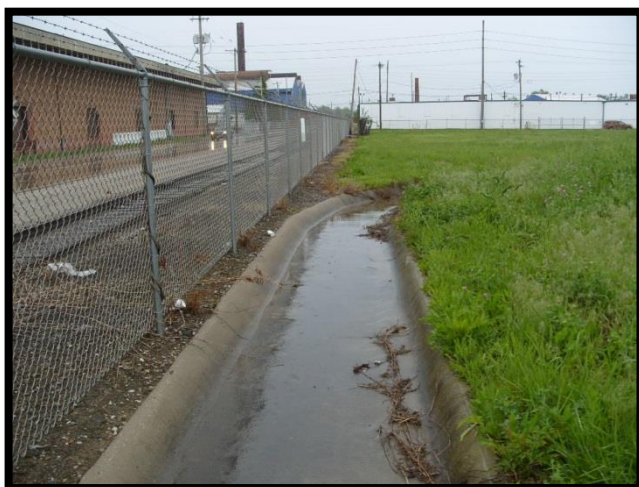
Photograph 7: Concrete drainage swale, north side of Taracorp pile (view southeast).

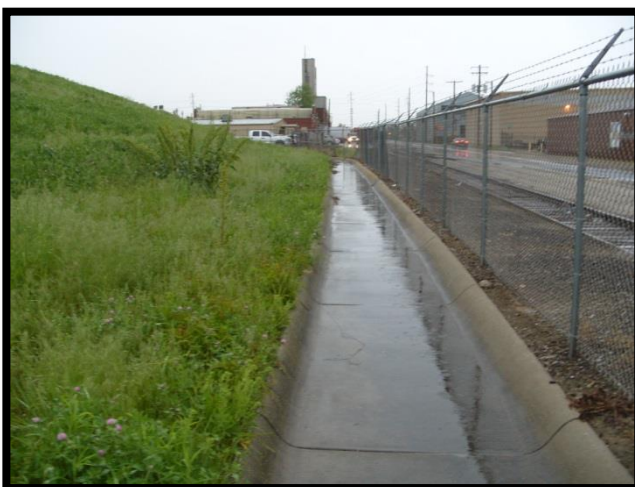
Photograph 8: Concrete drainage swale, fence, and vegetation; north side of Taracorp pile along 16<sup>th</sup> Street (view northwest).

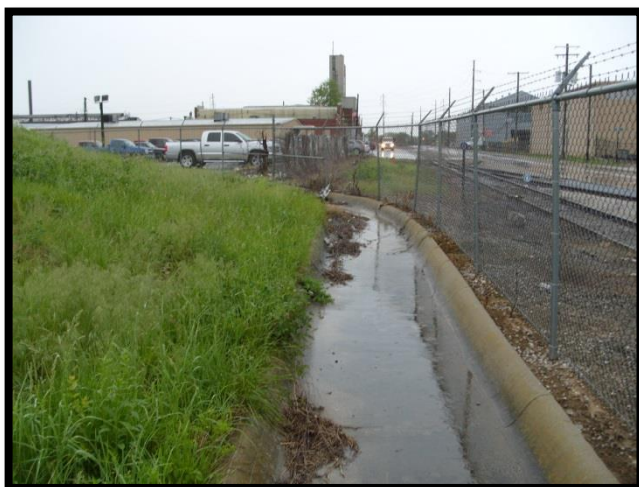
Photographs 9 and 10: Concrete drainage swale, fence, and vegetation; north side of Taracorp pile along 16<sup>th</sup> Street (view northwest).

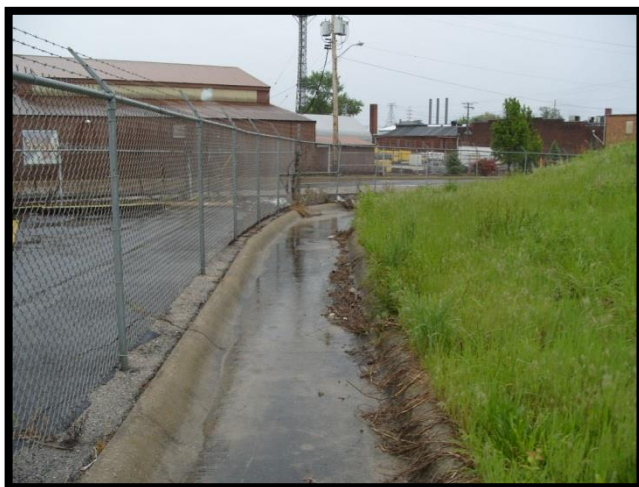
Photograph 11: Concrete drainage swale and vegetation, northwestern side of Taracorp pile (view northeast).

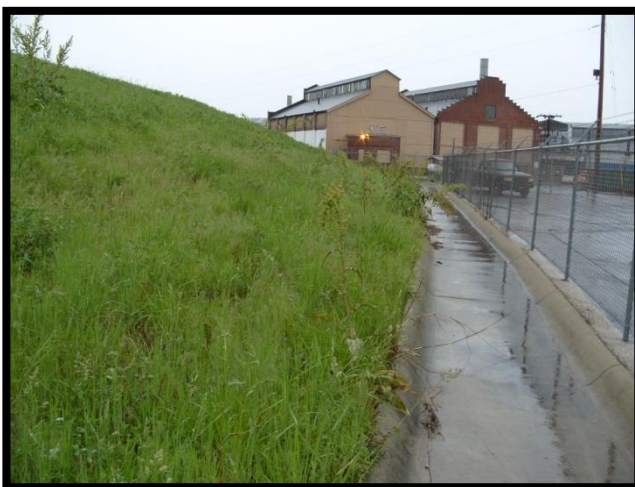
Photograph 12: Vegetation, northwestern side of Taracorp pile cap (view southwest).

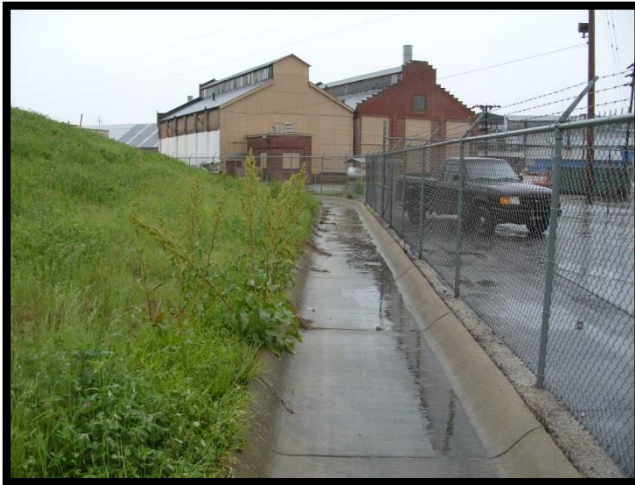
Photograph 13: Concrete drainage swale, fence, and vegetation along northwestern side of Taracorp pile (view southwest).

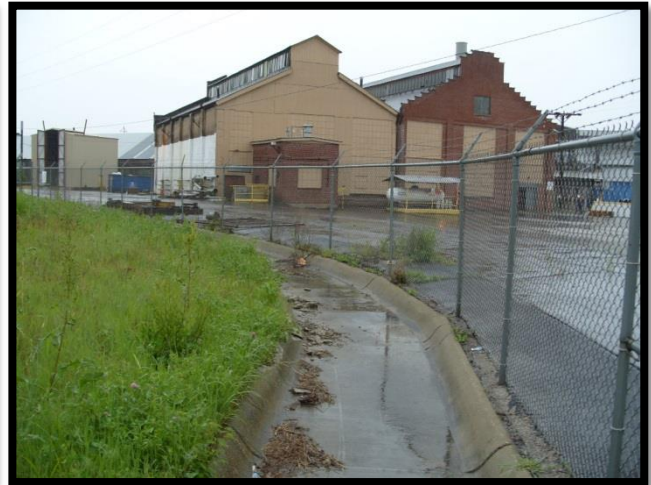
Photograph 14: Concrete drainage swale, fence, and vegetation along northwestern side of Taracorp pile (view southwest).

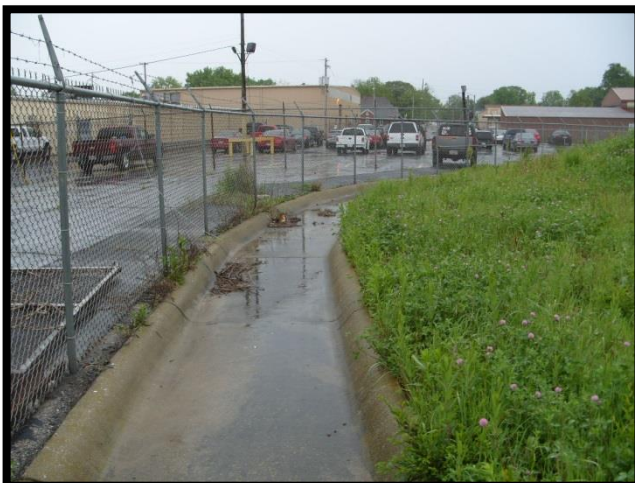
Photograph 17: Concrete drainage swale, vegetation along northwestern side of Taracorp pile (view north/northeast).

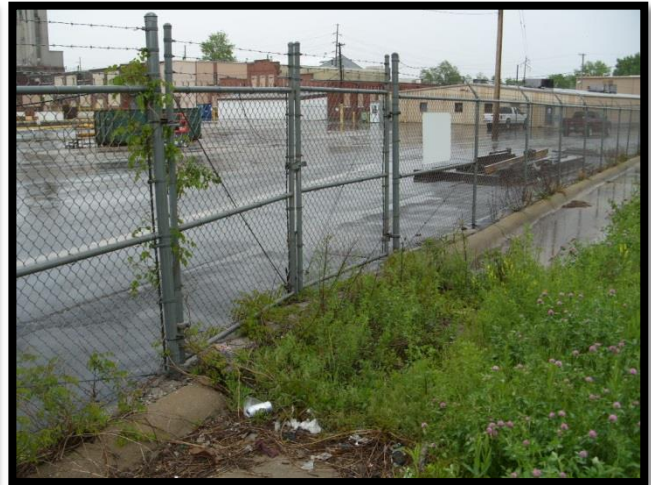
Photograph 20: Fence, gate, and warning sign along western side of Taracorp pile (view northwest).

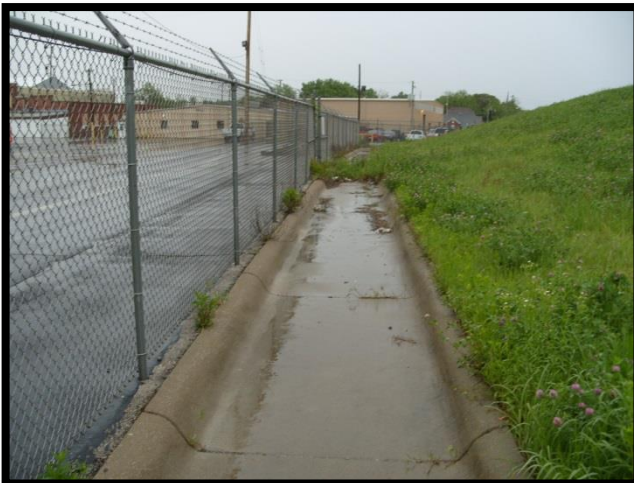
Photograph 21: Vegetation near base of western side of Taracorp pile (view north).

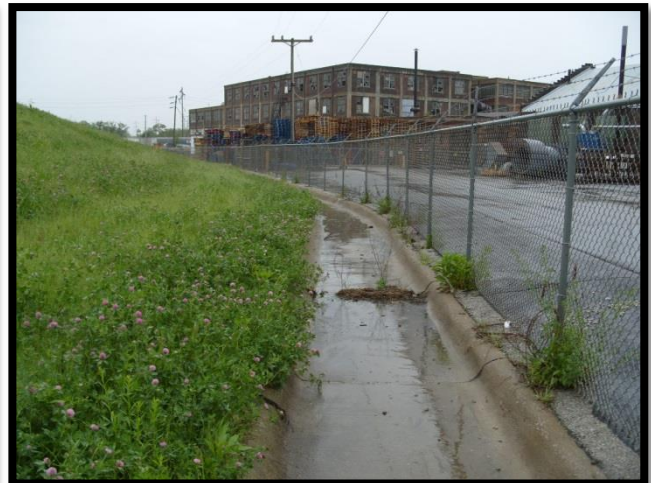
Photograph 22: Concrete drainage swale and vegetation near base of western side of Taracorp pile (view south).

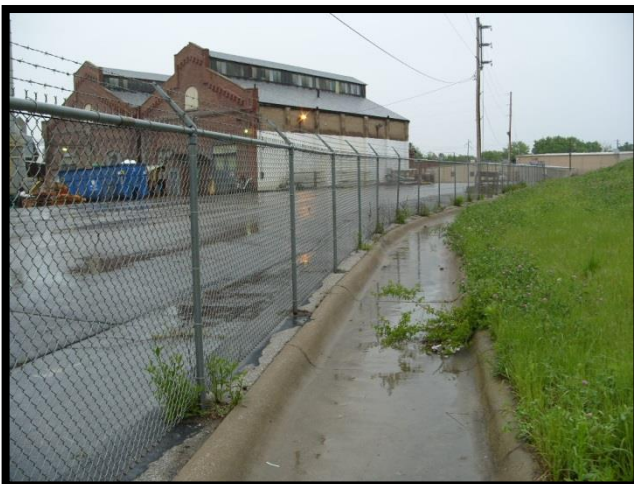
Photograph 23: Vegetation along western side of Taracorp pile (view north).

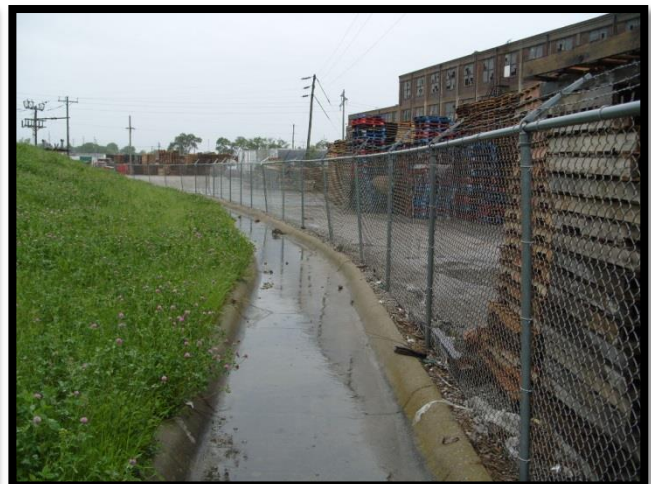
Photograph 24: Concrete drainage swale and vegetation near base of western side of Taracorp pile (view south).

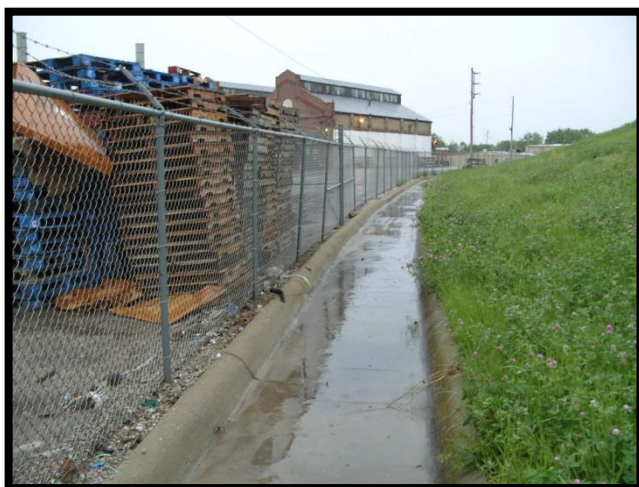
Photograph 25: Concrete drainage swale and vegetation near base of western side of Taracorp pile (view north).

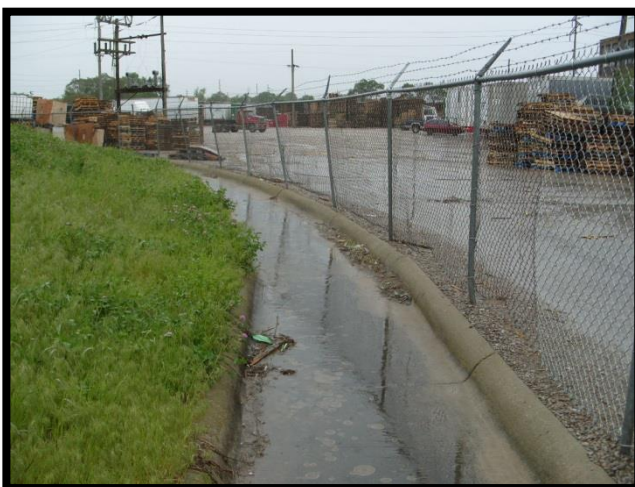
Photograph 26: Concrete drainage swale and vegetation near base of western side of Taracorp pile (view south).

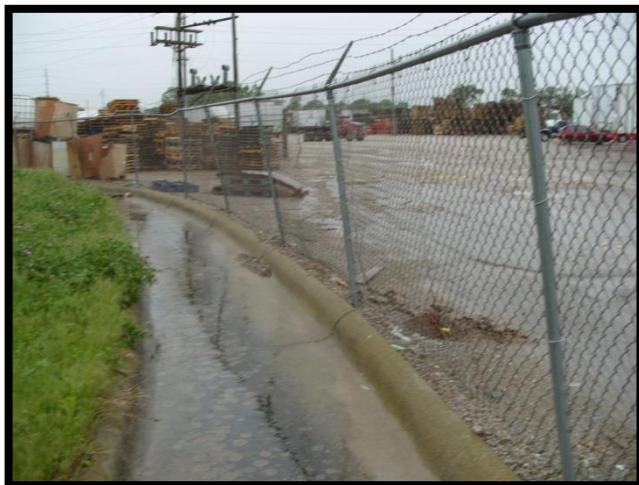
Photograph 27: Fence and concrete drainage swale (southwestern side of Taracorp pile cap).

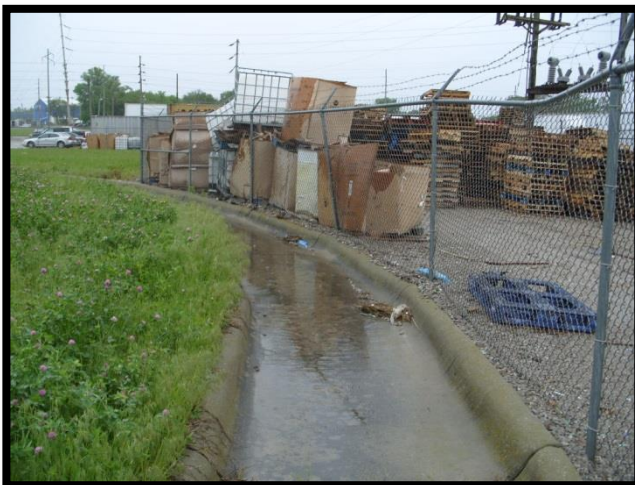
Photograph 28: Fence and concrete drainage swale (southwestern side of Taracorp pile cap).

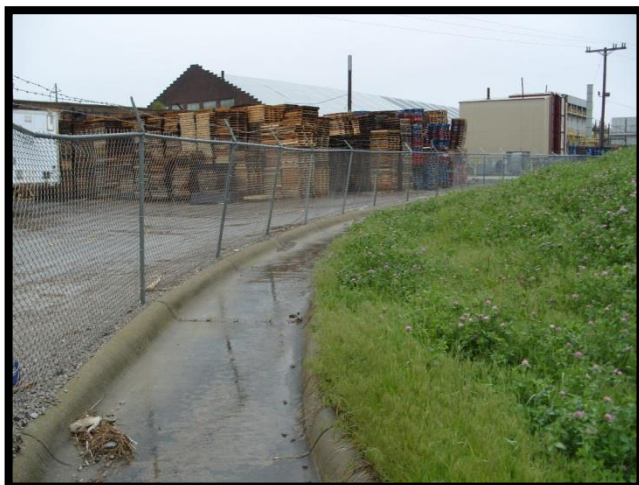
Photograph 29: Vegetation near base of southwestern side of Taracorp pile (view northwest).

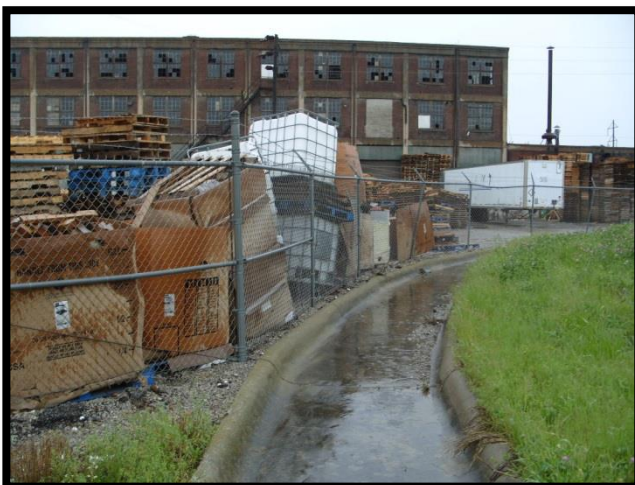
Photograph 30: Fence and concrete drainage swale (southwestern side of Taracorp pile cap).

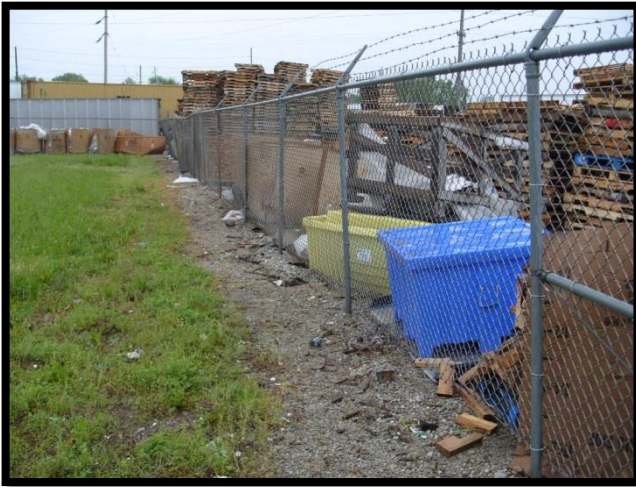
Photograph 31: Fence (material staging on State Street Warehouse property).

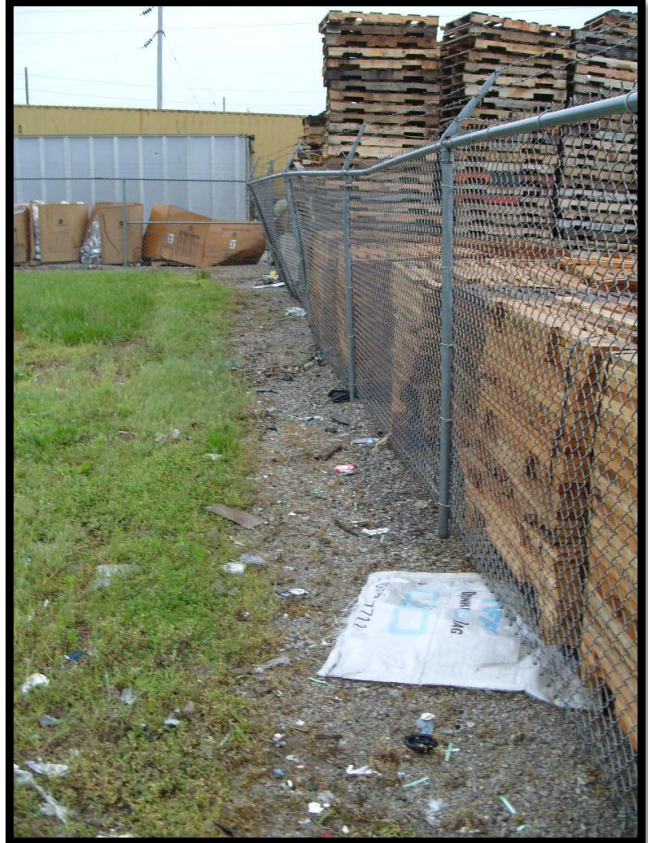
Photograph 33: Fence (material staging on State Street Warehouse property).

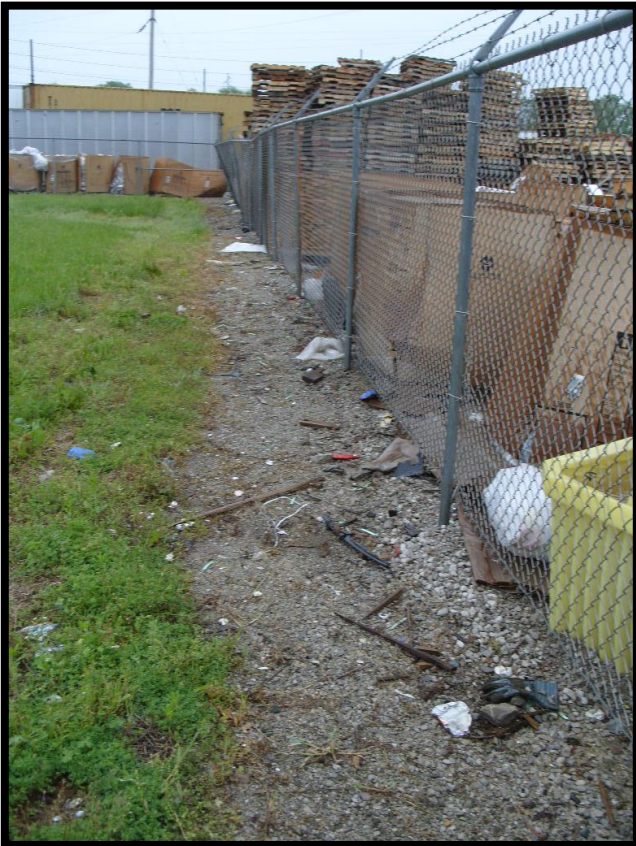
Photograph 32: Fence (material staging on State Street Warehouse property).

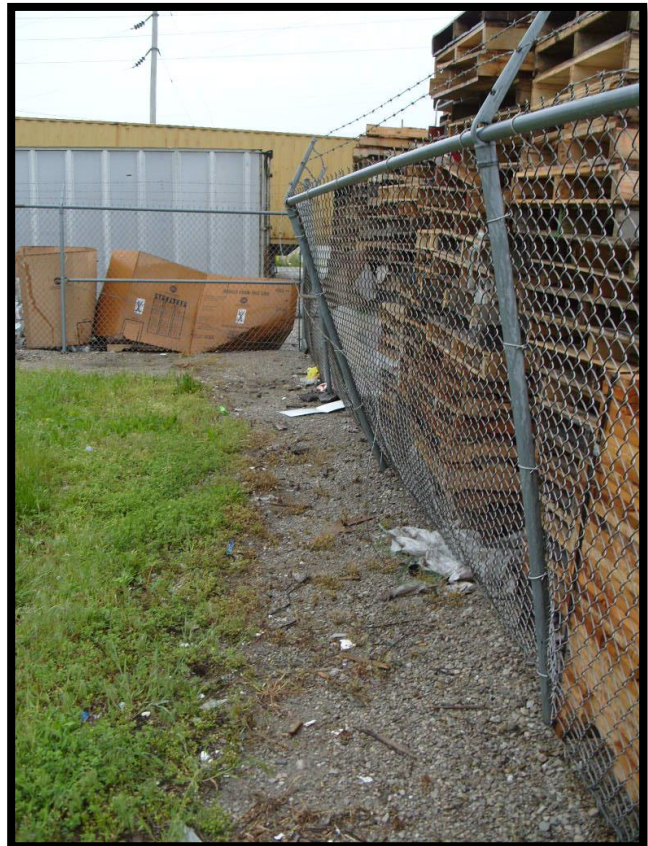
Photograph 34:  
Fence (material staging on  
State Street Warehouse property).

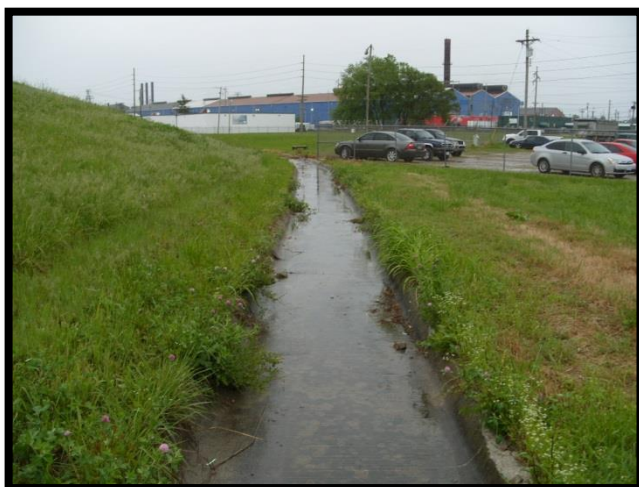
Photograph 35: Concrete drainage swale along southern slope of Taracorp pile.

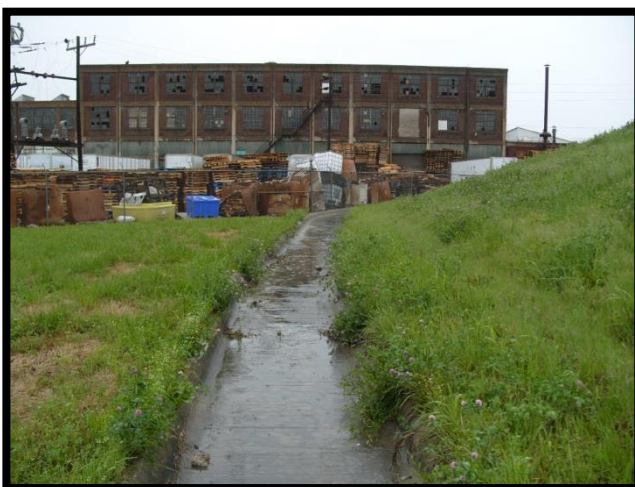
Photograph 36: Vegetation and concrete drainage swale along southern slope of Taracorp cap pile (view west).

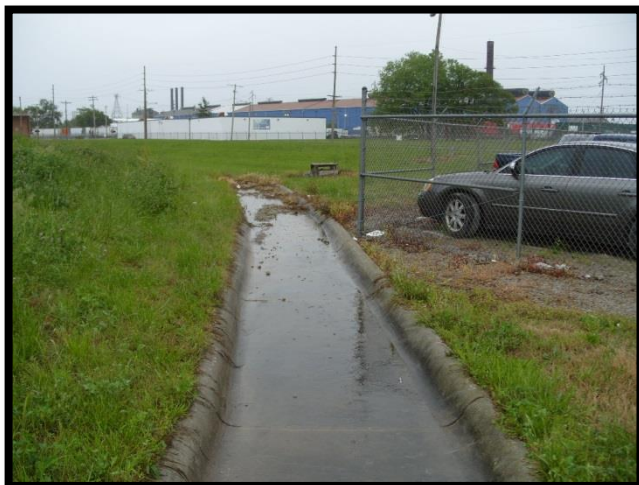
Photograph 37: Concrete drainage swale along southern slope of Taracorp pile.

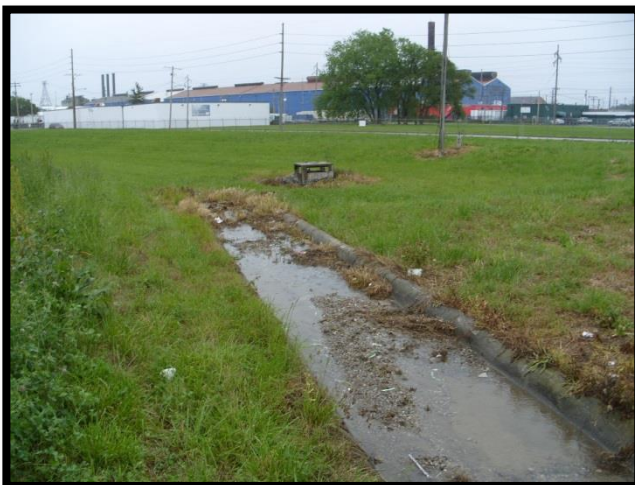
Photograph 38: Concrete drainage swale along southern slope of Taracorp pile.

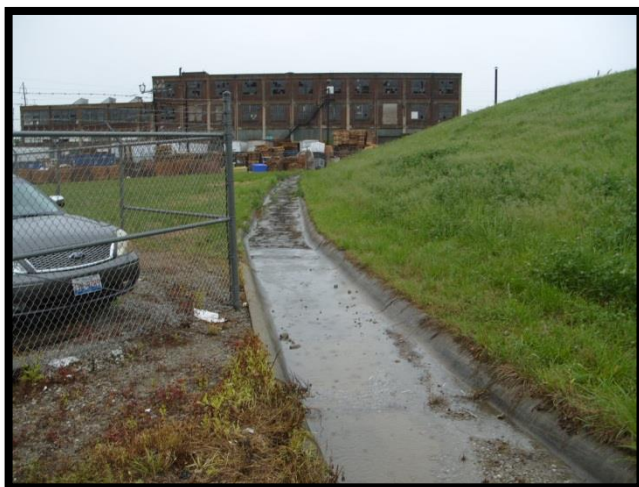
Photograph 39: Concrete drainage swale along southern slope of Taracorp pile.

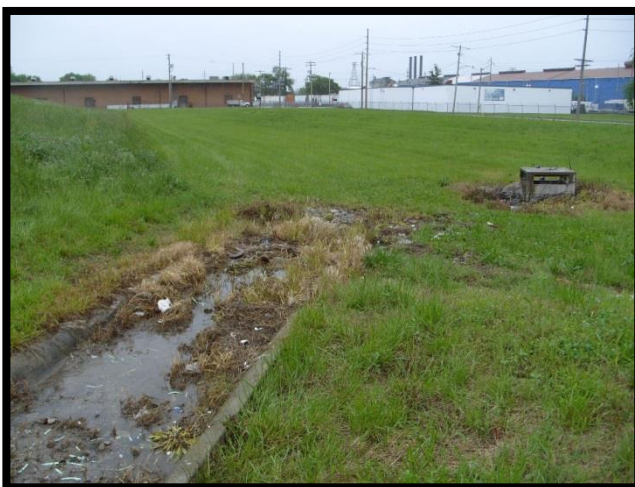
Photograph 40: Vegetation along southeast side of Taracorp pile cap (view northeast).
